**DOE CHALLENGE HOME
CASE STUDY****BPC Green
Builders**

New Fairfield, CT

FEATURED HOME/DEVELOPMENT:**Project Data:**

- Name: Candlewood Hills Rebuild
- Location: New Fairfield, CT
- Layout: 3 bedrooms, 3 baths, 2 floors
- Conditioned Space: 3,052 ft²
- Completion: Dec. 2012
- Climate Zone: 5A
- Category: Custom

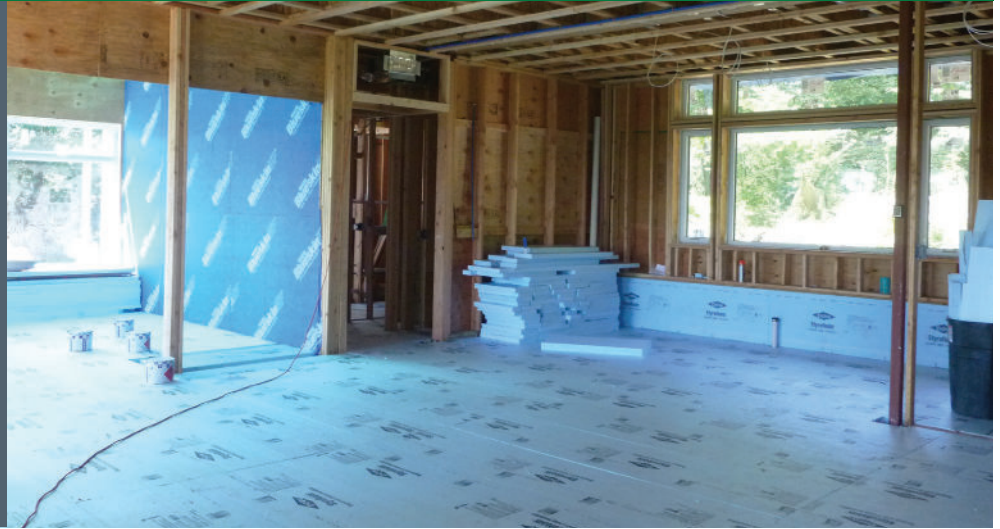
Rigid foam insulation covered the slab foundation, which included some old existing slab plus a new poured slab. The rigid foam also lined the interior and exterior of the foundation walls, providing a snug thermal break and moisture protection for first-floor radiant heating loops, which were set in 2 inches of gypcrete.

Some portions of the old slab were removed and replaced with new concrete slab. Then a liquid gypsum material was poured over both the new and old slab to level the surface. This was covered with R-20 (4 inches) of extruded polystyrene (XPS) rigid foam insulation. The radiant floor tubing was installed on the XPS and 2 inches of gypcrete was poured over this as a base for the tile floors. Rigid XPS (R-15) was installed along the foundation walls, 3 inches thick on the exterior and 1.5 inches thick on the interior, before the slab was poured.

- **Foundation:** R-20 (4 inches) XPS rigid foam insulation over existing slab and under new slab. 3 inches (R-15) XPS exterior, plus 1.5 inch (R-7.5) XPS on interior of foundation walls

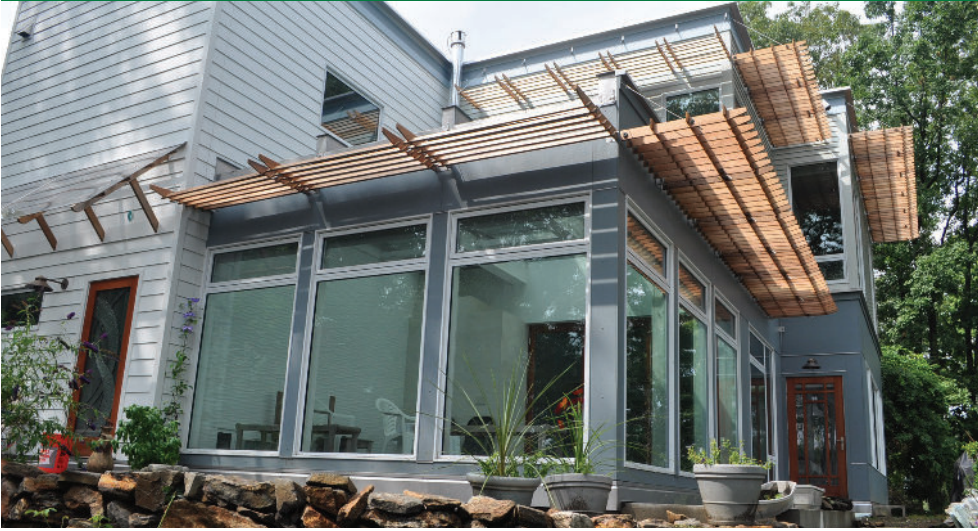
Nearly every room and closet in the home receives natural light through triple-pane low-emissivity windows or insulated solar tubes. Extra attention to air sealing helped the home achieve a very low air leakage rate of 0.45 ACH 50.

The highly insulating envelope was also heavily air sealed with all holes, joints, and cracks caulked or filled with spray foam. The Challenge Home requires that every home be tested for air leakage with a blower-door test. BPC Green Builders achieved a very low score of 0.45 air changes per hour at 50 Pascals pressure.

Every room in the home has natural daylighting via windows or solar tubes, including every closet but one—the closet under the stairs. All but one fixture in the home use LED or CFL bulbs; most are screw-based fixtures to accommodate future improvements in light sources. McKay designed the home's lighting plan, which includes 35 different lighting zones. Indirect lighting above built-in shelves is set by timers to consist of brighter lighting in the morning and warmer tones in the evening to encourage the occupants to wake up and feel sleepy at appropriate times. All of the actual dimmers and switches are high up in the closet, but 7-button, 1-gang controllers were installed on the walls to lump controls into fewer switch plates.

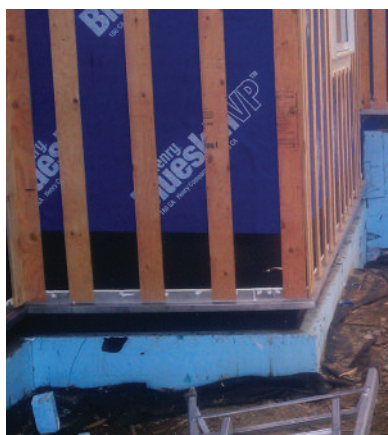
The exterior sheathing of the home was wrapped with a self-adhering vapor-permeable house wrap that serves as a weather-resistant air and water barrier. Furring strips were installed over this barrier allowing it to serve as a drainage plane for any bulk water that manages to get past the fiber cement siding.

The double-wall construction consists of a 2x6 24-inch on-center outer wall and a 2x4 24-inch on-center inner wall spaced 0.5 inches apart with staggered studs to provide a 9.5-inch cavity that was filled with R-33 of blown cellulose. The outer wall was sheathed with CDX plywood, covered with a layer of vapor-permeable, self-adhered, air- and water-barrier house wrap over which were installed 1x3 furring strips and fiber cement siding.
